# Manhole Inspection Summary

Manhole # S3700\_035MH

**Location** Address: **2206 BOONE ST**

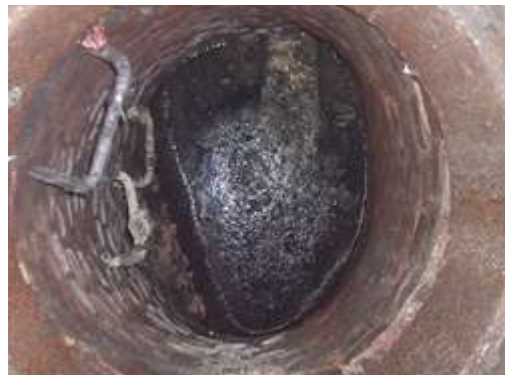
Top View

Frame leaks. Adjustment and Barrel infiltration. Evidence of surcharge - Bench debris. Channel debris.

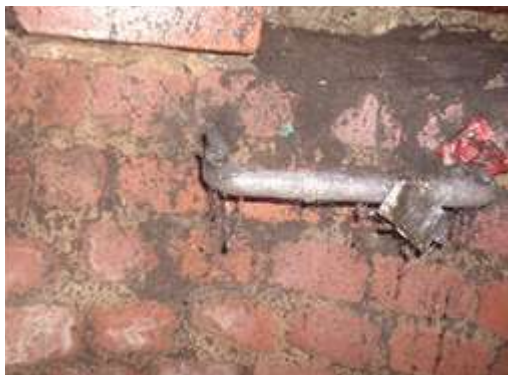
Defect

Adjustment deterioration, loose brick and infiltration.

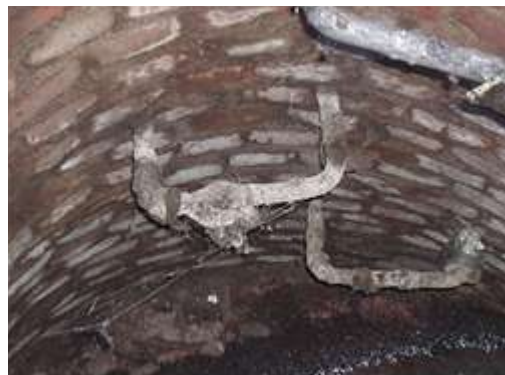
Defect

SURCHARGE EVIDENCE ON STEPS

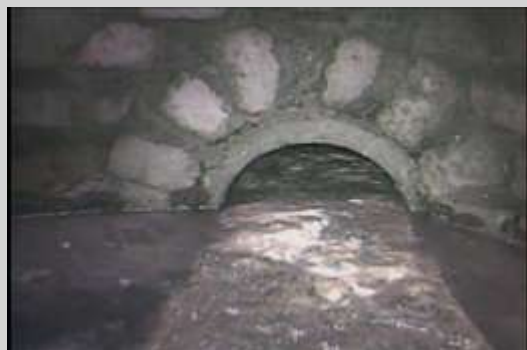
Pipe Out @ 12 O'Clock

Deposits: ☐ None ☒ **Mud** ☐ Sludge ☐ Debris ☒ **Grease**

Silt Depth: **4** (in.)

Deposits Extent: **Heavy**
